## Outbuilding at High House Farm, High Common, Wreningham

***Steve Hickling, 12<sup>th</sup> August 2022 for the Wreningham History Group***

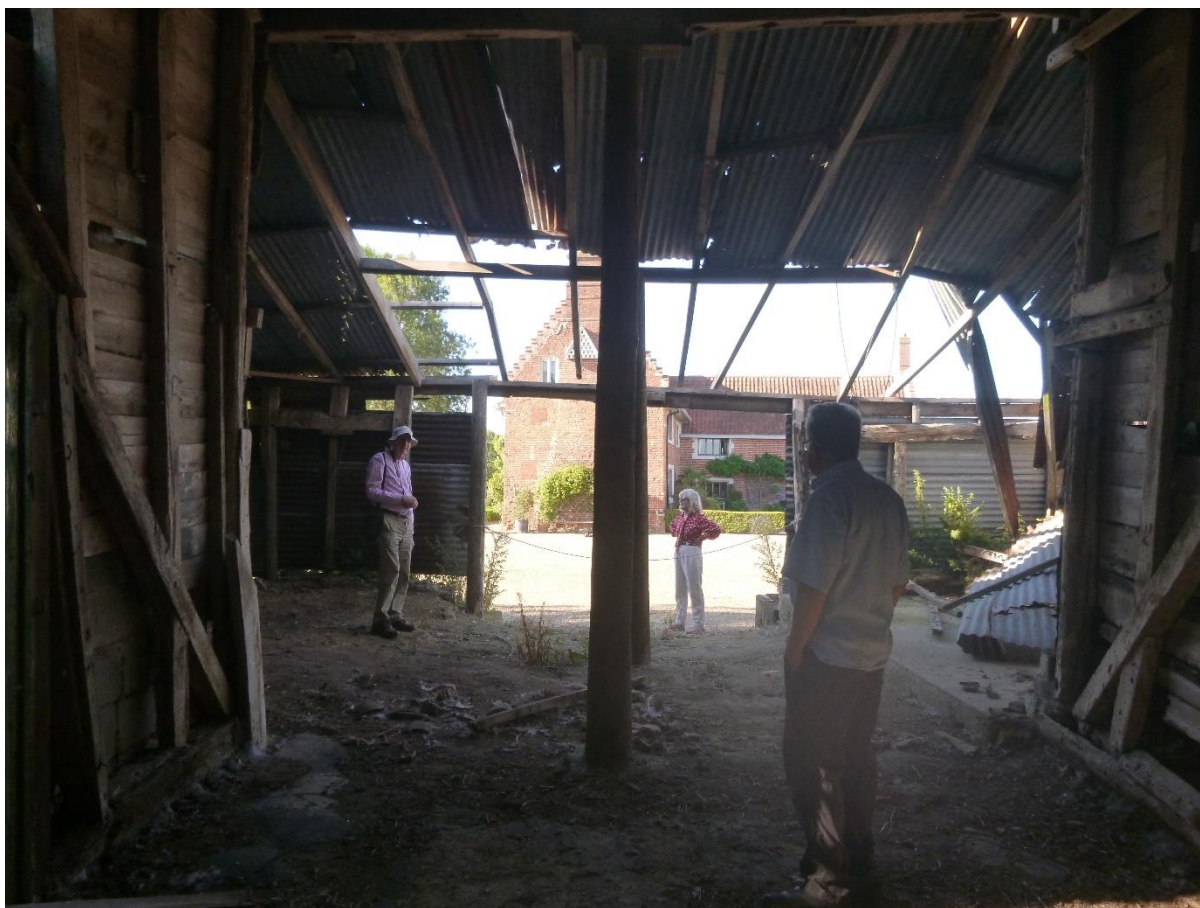
*The interior, facing north taken from the 19<sup>th</sup> century barn porch with High House in the background*

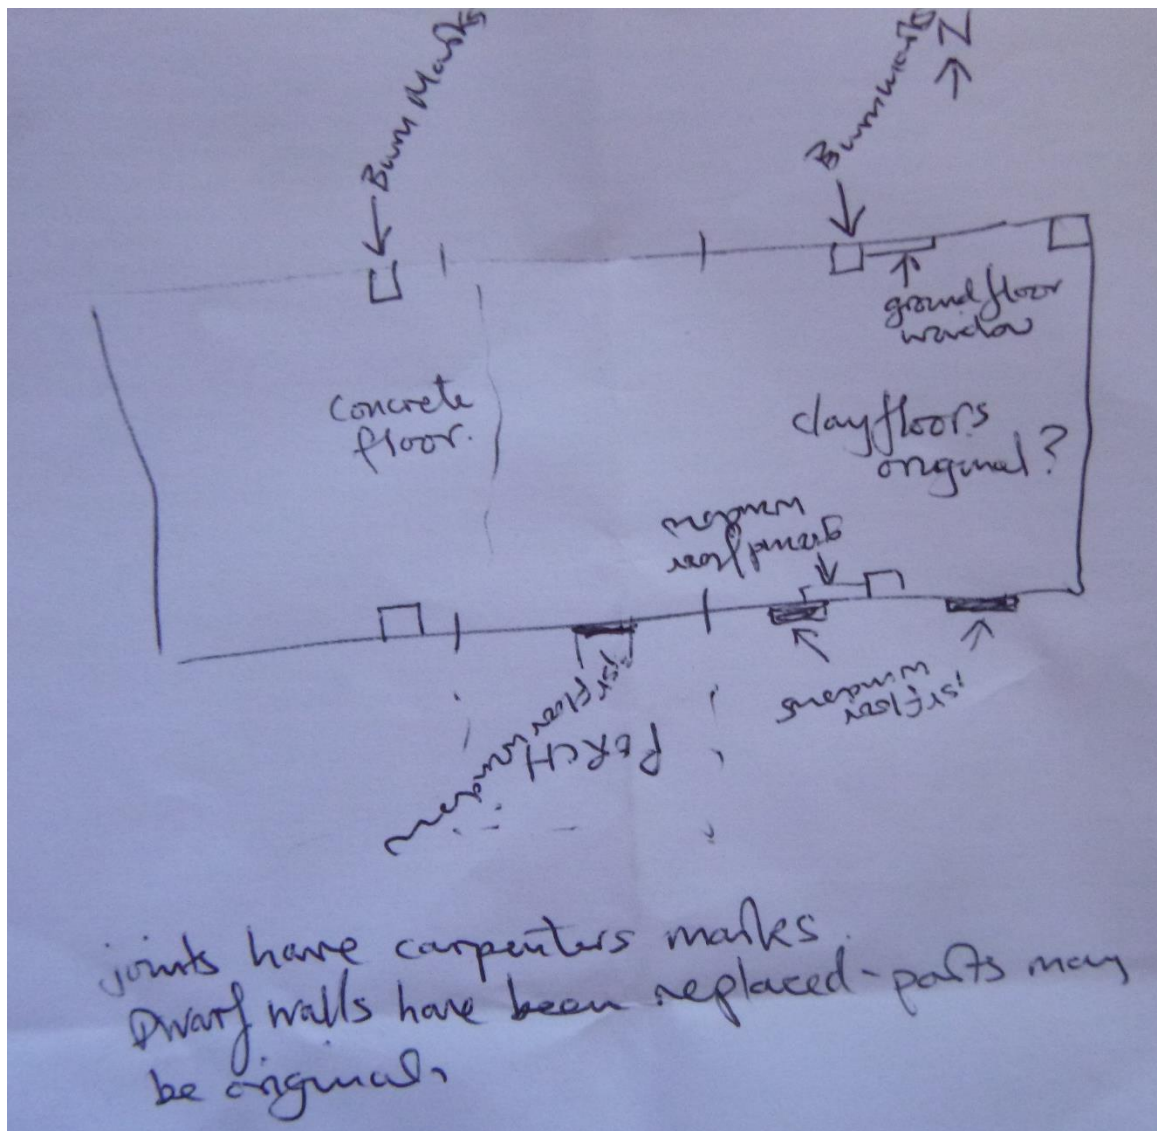
Virtually the whole of the south wall survives up to the level of the eaves (the 'Wall Plate'), but the western end has suffered and much of the timber framing there has been replaced and covered on the outside with weatherboarding (unusual in Norfolk). At the wall's eastern end, many panels of the original wattle and daub infilling remain, although it is rapidly decaying. Three first floor windows were identifiable, the eastern one still has its diamond mullions with no evidence of ever containing glass. The other two first floor windows were only identifiable from the joints for the diamond mullion showing on the underside of the wall plate. Likewise, the two ground-floor windows (one on the south wall, one on the north wall) were only identified by the joints on the underside of the 'girding beam' (the horizontal beam that would have supported the first-floor floor beams).

The north wall only survives to just above the upper floor level, meaning it is now half the height of the south wall.

The west gable end has totally gone, replaced by a clay-lump lower wall with corrugated iron above.

The east gable framing is mostly intact, but the upper portion has gone.

The floor of the eastern portion has been covered with cast concrete, but there is evidence that the original clay floor may survive in the western bay.

The building would have had a brick-built, off-centre chimney stack but there is no visible evidence of this. The surviving framing suggests that it would have been located between the western and central bays.

Only five out of the original, perhaps 10 Truss posts survive wholly or in part.

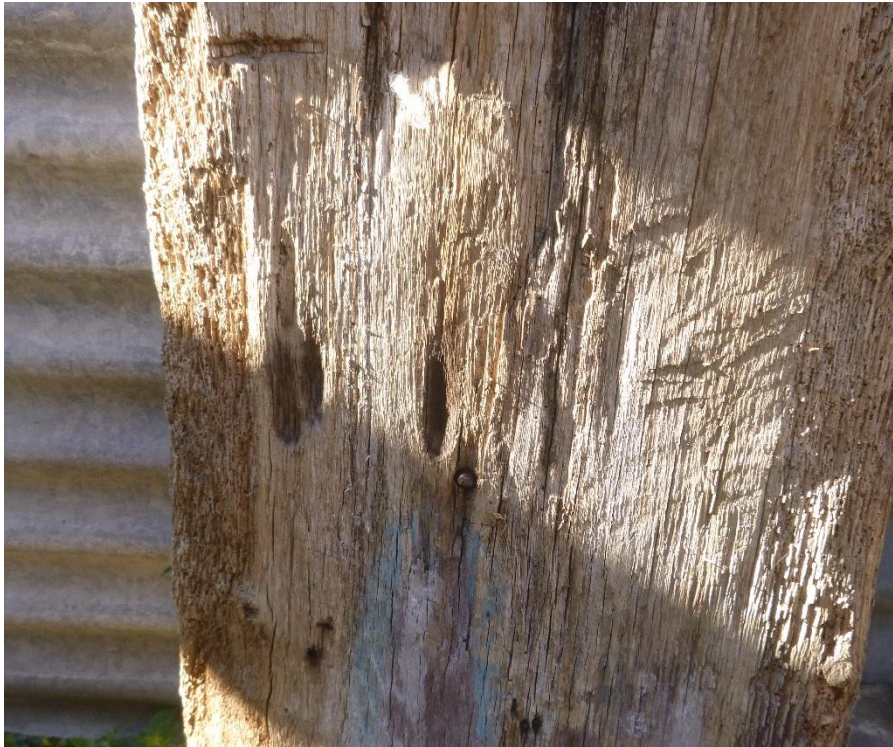
- There are 'burn marks' on two of the truss posts (the trusses are the transverse frames separating the bays or rooms in this case) made by candles, tapers or rush lights in the north wall and on a displaced timber (probably a wall stud) lying on the concrete floor of the eastern bay. These may be 'apotropaic' marks, a folk-charm guarding against the danger of accidental fire. These are often thought to be where candles or tapers have been placed to provide light internally, which have accidentally burnt the timber. However, people who live in timber houses tend to be very wary of the danger of accidental fire, so this explanation is unlikely. Also, they often occur associated with fireplaces – where additional light is probably least needed!

*Ritual burn marks on the northeastern-most surviving truss post*

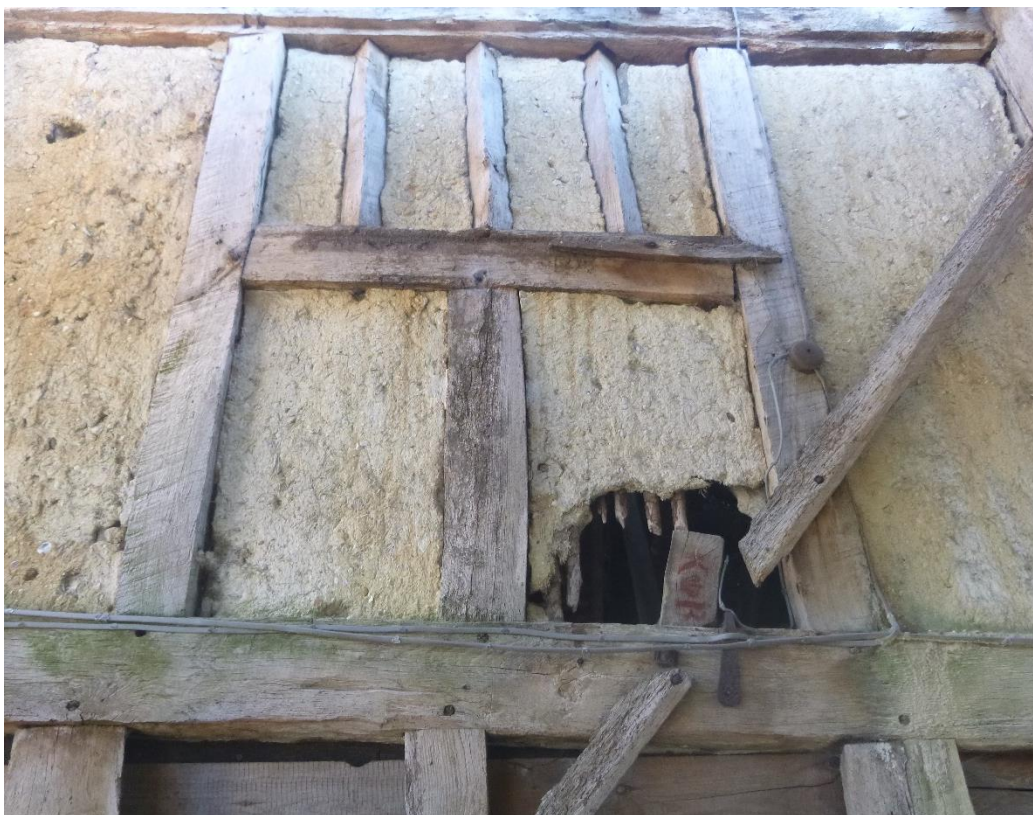
*The eastern-most first floor window, internal view, showing the diamond mullions and the form of wattle and daub infilling*

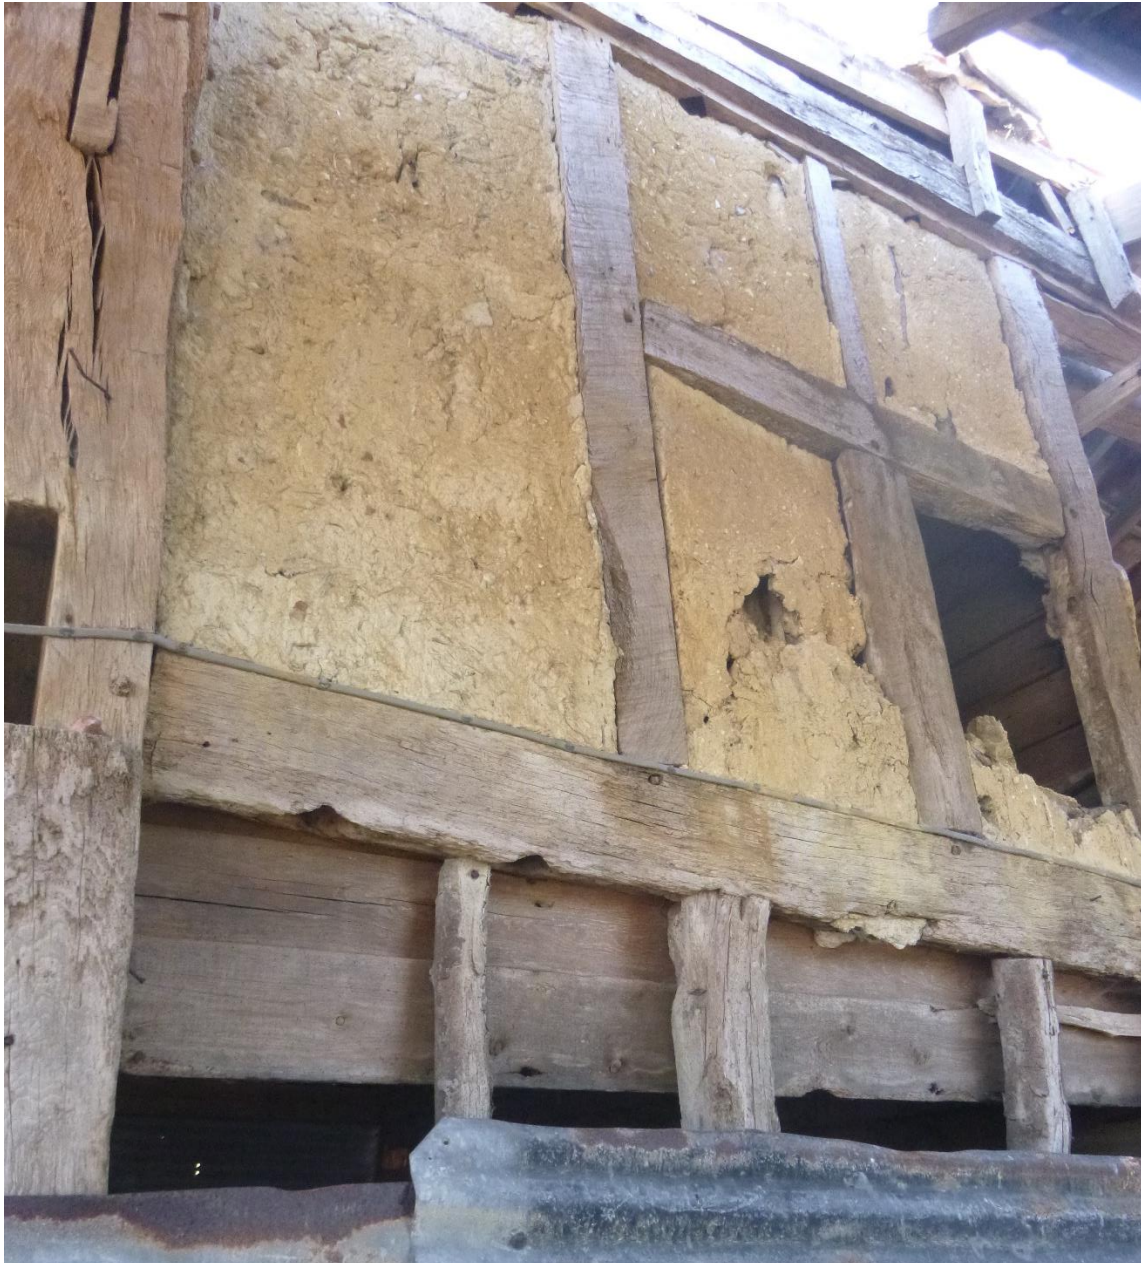
*The central first floor window (infilled) with the joints for a ground-floor window visible on the underside of the girding beam. The wall plate is above the first-floor window and the easternmost surviving truss post of the south wall to the left*

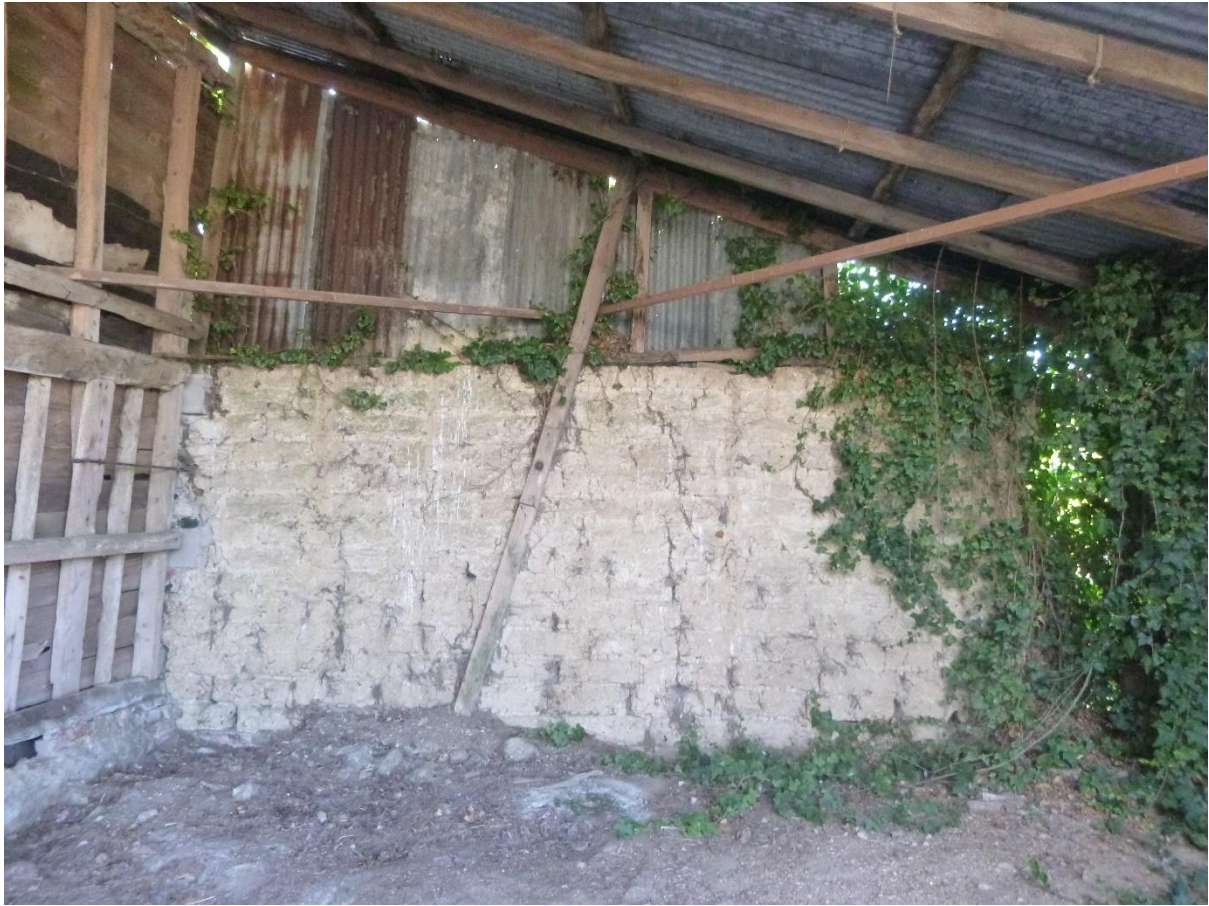
*The western gable, completely replaced by a c.19<sup>th</sup> century clay lump wall and 20<sup>th</sup> century corrugated iron.*

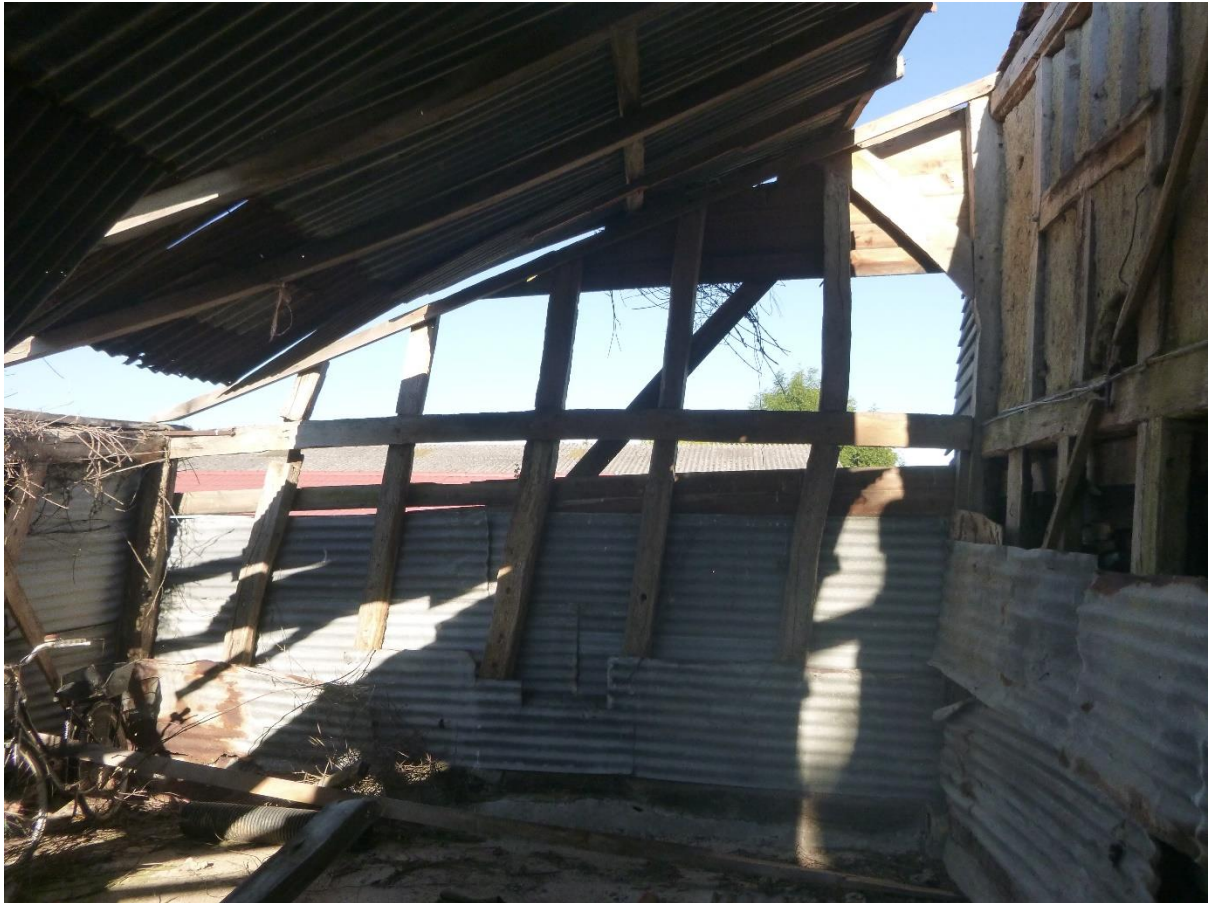
*The eastern gable with a girthing beam (the horizontal beam) and one surviving brace (the upper right diagonal beam) and some original wall studs (the smaller, vertical beams)*

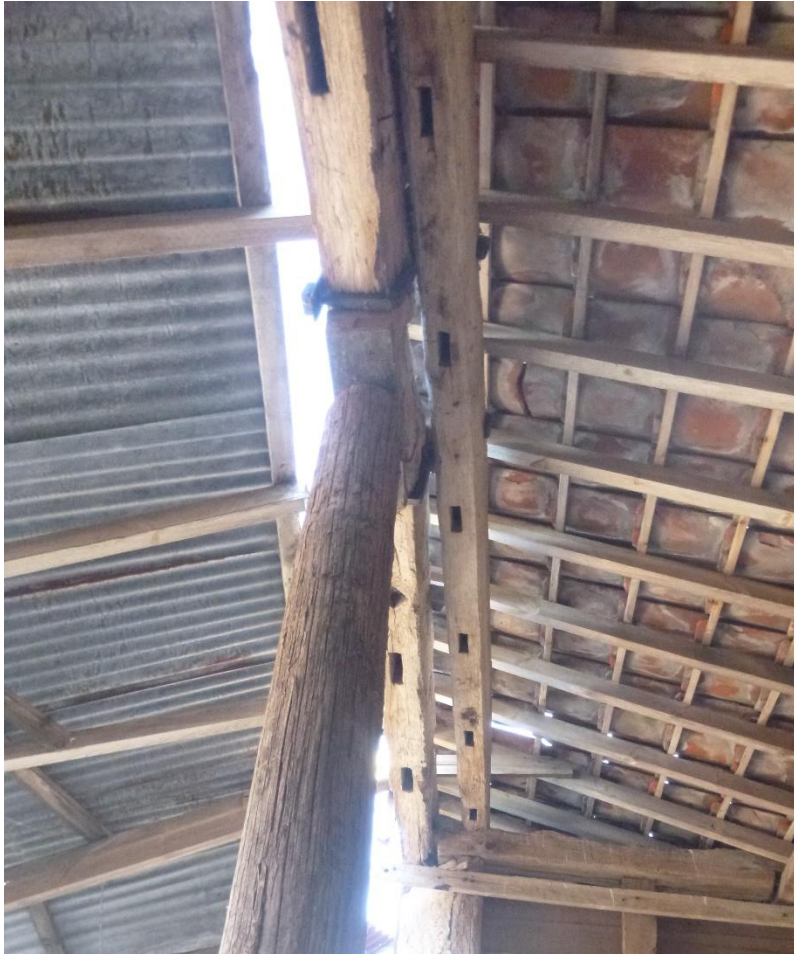
In its later life, perhaps in the 19<sup>th</sup> century, the house was converted into a barn by removing its chimney stack, internal walls, first floor and creating two large, two storey opposed entrances to enable carts to enter and to create a through draft, useful when threshing grain. A porch was added on the south side, largely constructed from reused timbers from those elements removed in the conversion. The opening of the south entrance has caused a major structural failure of the wall plate above the south entrance, which was always going to be a weak spot due to the simple scarf joint there. This was initially reinforced by attaching a reused beam (perhaps originally an internal wall beam) as reinforcement, then further reinforced by placing a reused telegraph pole to support the weak scarf joint.

*The failed wall beam by the 19<sup>th</sup> century south doorway. The 19<sup>th</sup> century barn porch is to the right, the central cell of the 17<sup>th</sup> century house to the left. The joints on the underside of the wall plate are for the wall studs, and one window mullion is just visible behind the telegraph post. The telegraph post supports the failed scarf joint, which had previously been strengthened by the addition of a reused 17<sup>th</sup> century beam (probably an unneeded girding beam) joined to it by iron framing.*

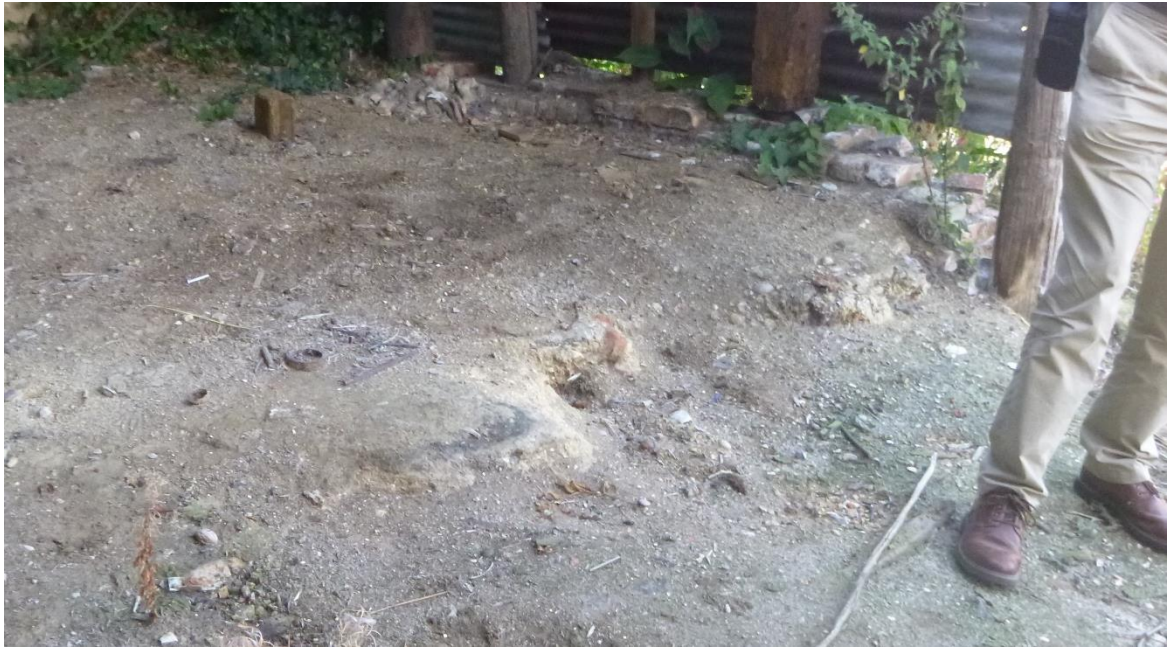
*The probable remains of clay internal flooring, perhaps original to the house*
